Re: Mason Golf Center
Schaefer Project Number: 1611.04

Per the request of Mr. Richard Fair of City of Mason, I visited the referenced building on January 14 & 15, 2016. The purpose of the visit was to observe the existing conditions related to building movements recently noticed by the Golf Center staff. The section of the building investigated is the retail space at the north end of the building (see Photo 1). This section of the building is approximately 40' x 40' square, and is one story tall with a basement. The exterior walls are a combination of loadbearing wood studs and glass with wood beams and posts supporting the roof. The roof framing consists of 2x8 rafters sloping up to a flat roof area that is approximately 20 feet square. The interior space is open to the roof framing. There are wood roof beams at the four sides of the high flat roof area. The beams were measured to be (3) 2 x 8's on the east edge of the flat area and (3) 2 x 12's on the north edge. It is assumed that the (3) 2 x 8 beam also occurs on the west edge and the (3) 2 x 12 beam also occurs on the south edge of the high roof. The high flat rafters span in the east to west direction and are supported by th

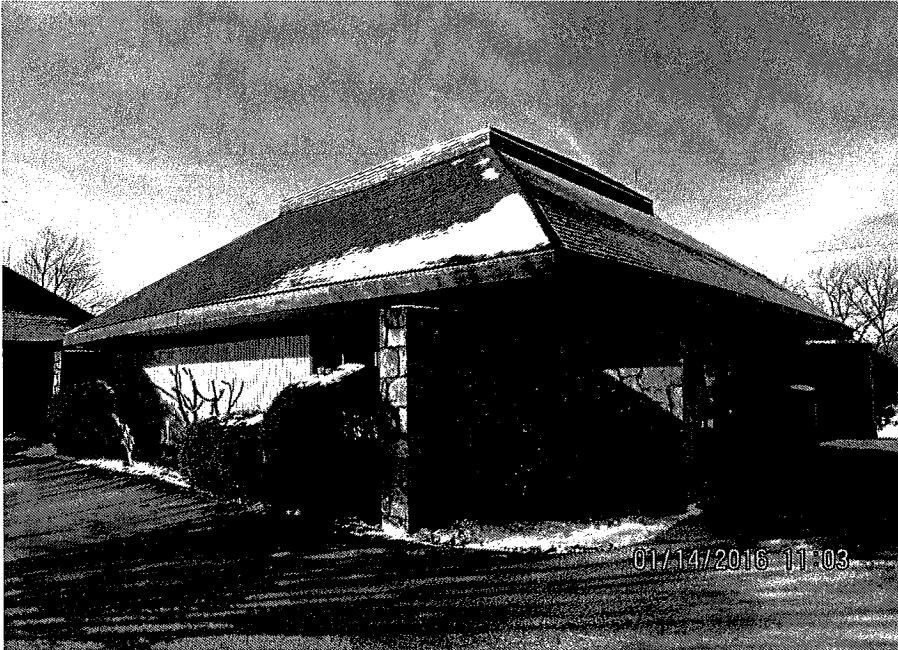
- The north, east and west exterior walls are out of plumb approximately 3 to 4 inches over their height. The tops of these walls are kicking outward.
- There are gaps between the exterior walls and some of the interior perpendicular partition walls.
- The roof surfaces above the sloped roof rafters are very uneven and wavy, primarily at the east and west sloped roof areas.

Photo 1- Building Exterior, Northeast Corner

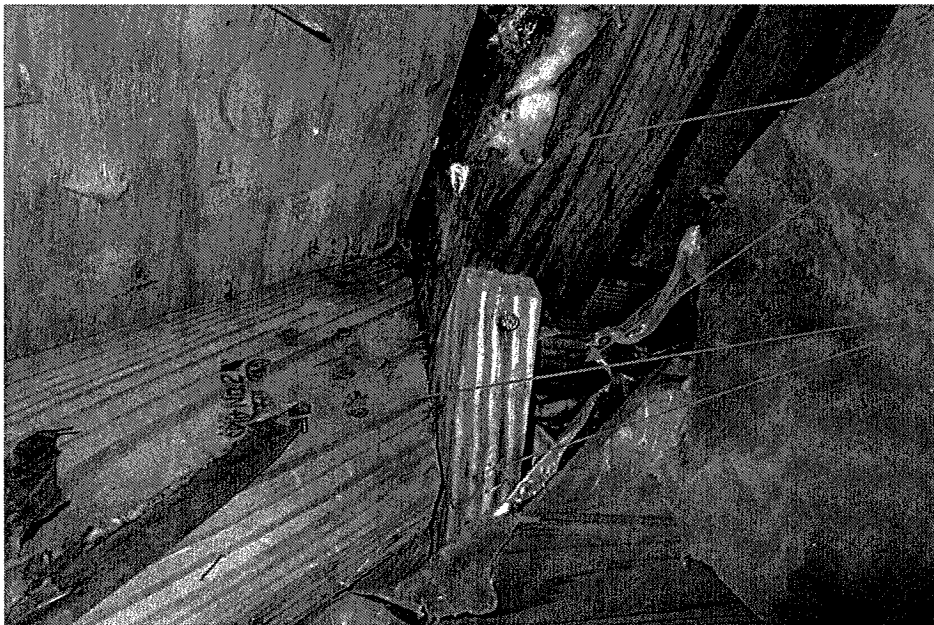
- The triple 2 x 8 beams at the east and west edge of the high flat roof area are approximately 200% overstressed. This presents a dangerous condition.
- The connection between the slopping 4 x 8 hip rafter and the high roof perimeter beams consists of several nails (see Photo 2). The load transfer that is required at this location is approximately 7000 lbs. This existing nailed connection is extremely overstressed and is a dangerous condition.

Flat Roof Beam

Sloped Roof Rafter

Photo 2 – Northeast Corner of High Flat Roof

As a result of the overstressed conditions noted above it was recommended that the building be evacuated until temporary shoring is installed. The recommended temporary shoring consists of 6 vertical shoring columns. Three posts will be located below each (3) 2x8 beam at the east and west edge of the high flat roof area. See the attached plan and section for the location and construction of these columns. Once the shore posts are installed, the danger to the building occupants from these overstressed conditions will be removed.

A more permanent building repair will be required in order to satisfy the building code structural requirements. Schaefer is available to provide construction documents for this work once the City of Mason decides to proceed with this additional reinforcing. The permanent repairs will consist of a new interior beam directly below the east and west edge of the high flat roof area. Supporting each of these two beams will be two interior wood columns located within approximately five feet the sloped rafters. In the basement, below each of these four columns, there will be an adjustable steel column bearing on a new concrete footing. The locations of the upper and lower columns will need to be coordinated to reduce the impact to the partition walls on both floor levels.
