Re: Mason Golf Center
Schaefer Project Number: 1611.04

Per the request of Mr. Richard Fair of City of Mason, I visited the referenced building on January 14 & 15, 2016. The purpose of the visit was to observe the existing conditions related to building movements recently noticed by the Golf Center staff. The section of the building investigated is the retail space at the north end of the building (see Photo 1). This section of the building is approximately 40' x 40' square, and is one story tall with a basement. The exterior walls are a combination of loadbearing wood studs and glass with wood beams and posts supporting the roof. The roof framing consists of 2x8 rafters sloping up to a flat roof area that is approximately 20 feet square. The interior space is open to the roof framing. There are wood roof beams at the four sides of the high flat roof area. The beams were measured to be (3) 2 x 8's on the east edge of the flat area and (3) 2 x 12's on the north edge. It is assumed that the (3) 2 x 8 beam also occurs on the west edge and the (3) 2 x 12 beam also occurs on the south edge of the high roof. The high flat rafters span in the east to west direction and are supported by th

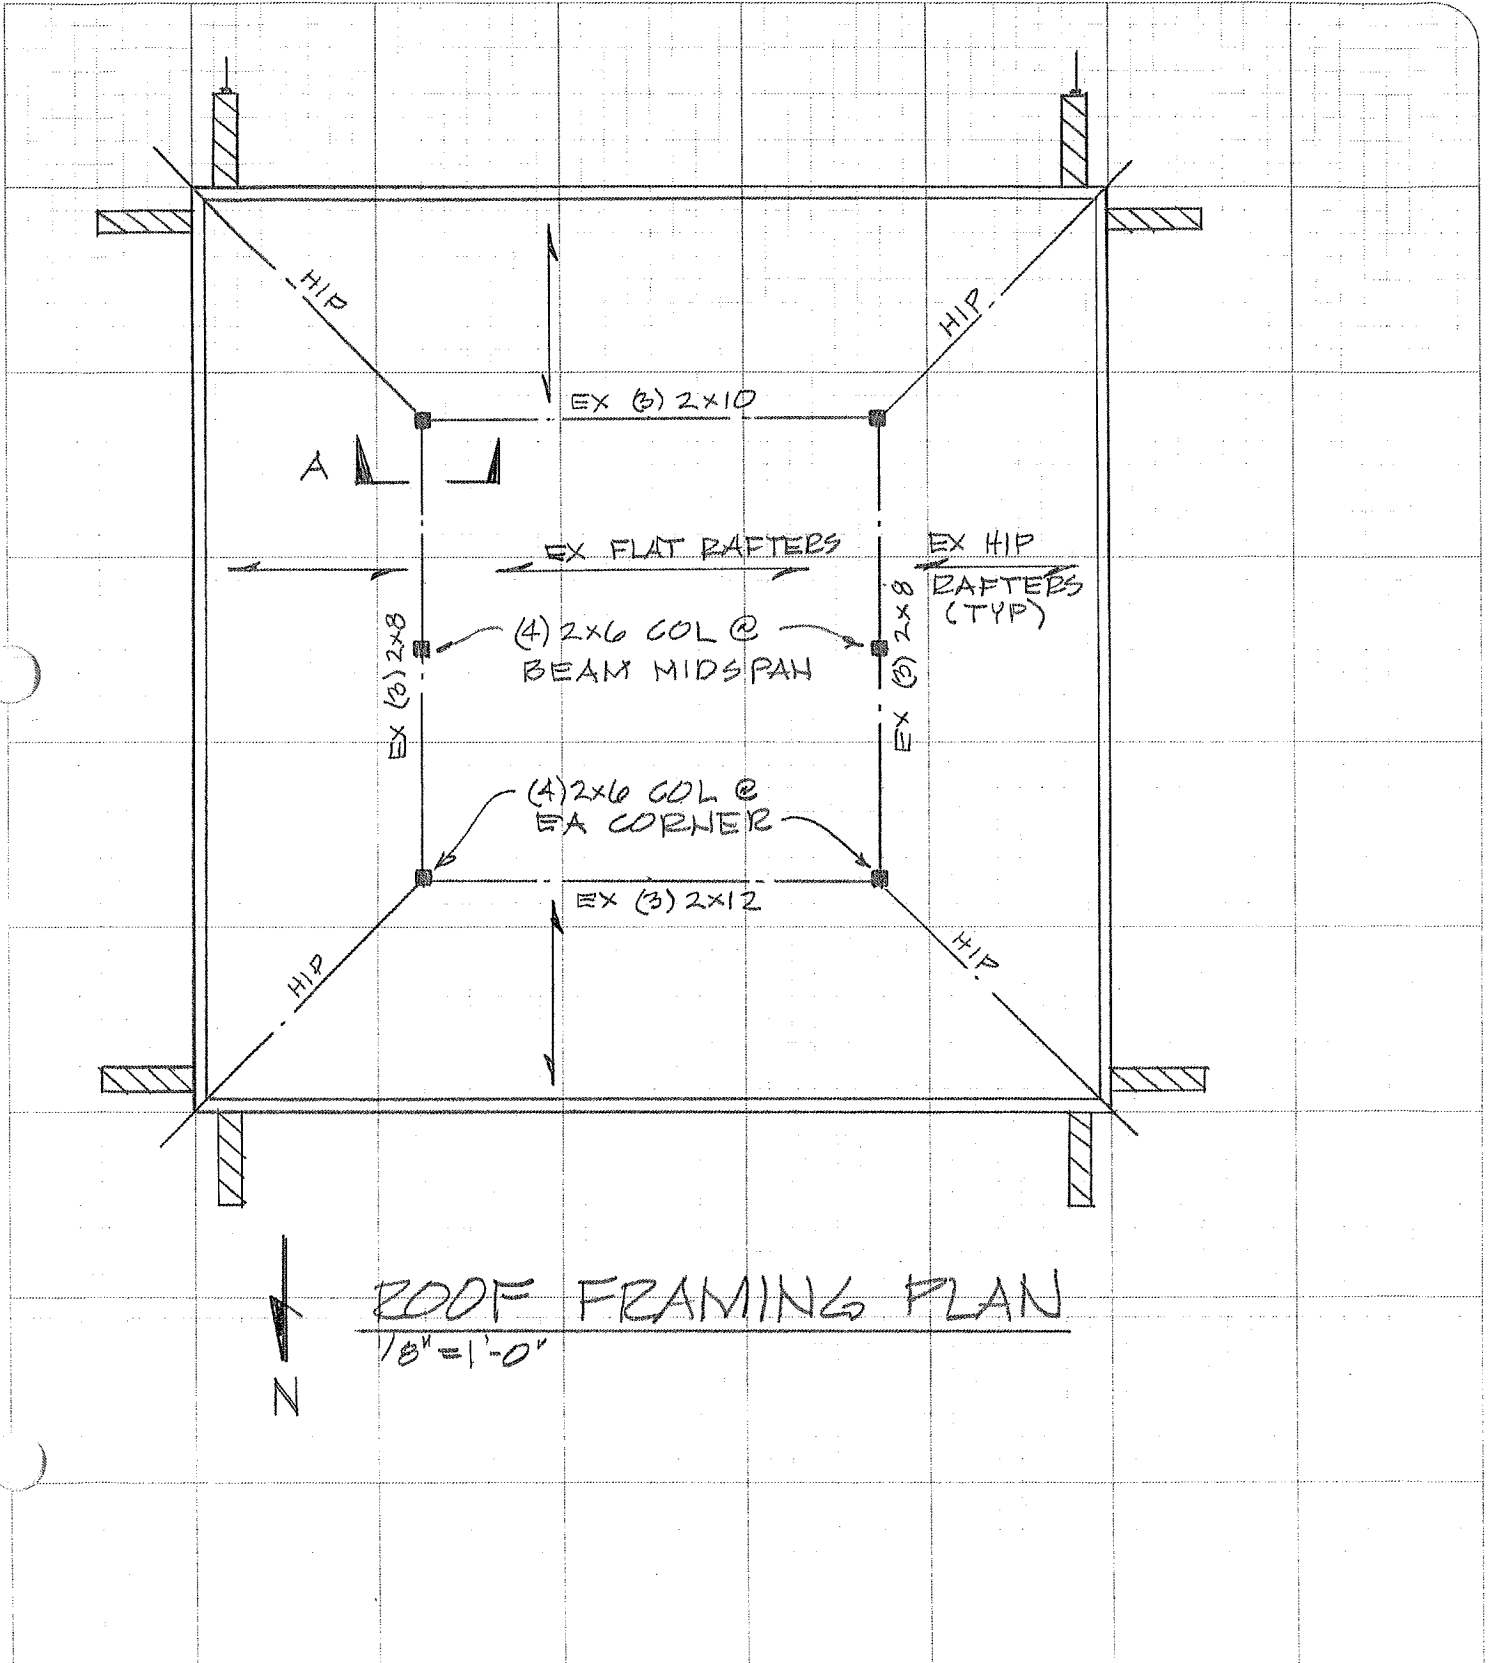
ROOF FRAMING PLAN
1/8" = 1'-0"

- The triple 2 x 8 beams at the east and west edge of the high flat roof area are approximately 200% overstressed. This presents a dangerous condition.
- The connection between the slopping 4 x 8 hip rafter and the high roof perimeter beams consists of several nails (see Photo 2). The load transfer that is required at this location is approximately 7000 lbs. This existing nailed connection is extremely overstressed and is a dangerous condition.

As a result of the overstressed conditions noted above it was recommended that the building be evacuated until temporary shoring is installed. The recommended temporary shoring consists of 6 vertical shoring columns. Three posts will be located below each (3) 2x8 beam at the east and west edge of the high flat roof area. See the attached plan and section for the location and construction of these columns. Once the shore posts are installed, the danger to the building occupants from these overstressed conditions will be removed.
